**Service Action: Replace the Selective Catalyst Reduction (SCR) Metering Unit**

E90 with the M57Y engine

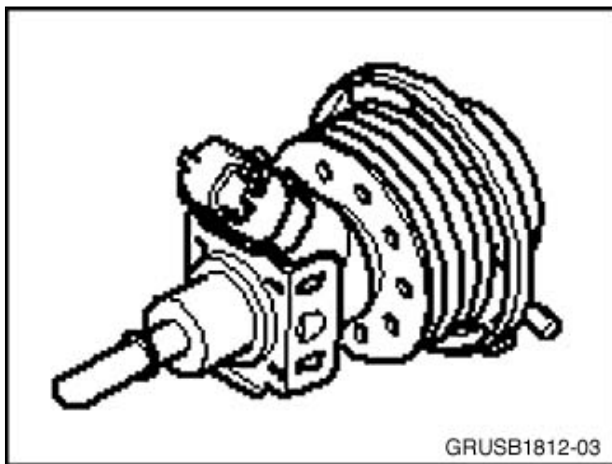
Metering units installed on certain E90 vehicles with the M57Y diesel engine will clog due to crystallization of the DEF fluid. An improved metering unit has been introduced.

Replace the metering unit as described in Repair Instruction RA 18 31 130.
