This Service Information bulletin supersedes SI B63 02 08 **dated October 2009**.

#### Rear Bulb Failure

E92 (3 Series Coupe) vehicles produced up to May 30, 2009

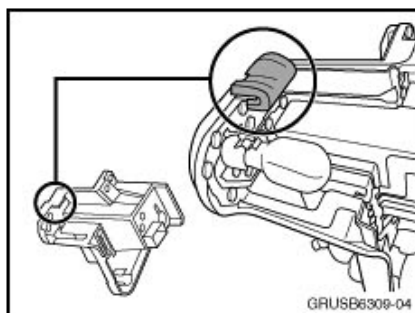
- Poor fit between the bulb and bulb holder (old design bulb holder)
- Bulb failure caused by vibration (new design bulb holder)

- **NEW** Before installing the new part, apply a foam rubber anti-vibration strip as shown.
- Install the bulb holder in the vehicle.

- Do not replace the bulb holder. Replace any failed bulbs.
- **NEW** Apply the anti-vibration strip as described above before reinstalling the bulb holder.
