Product Quality Update

Situation

- E82/E88 (1 Series), E89 (Z4), E9x (3 Series) vehicles up to 5/30/2011
 - Vehicle fails to start
 - Door locks inoperative
 - Vehicle electrical system failure

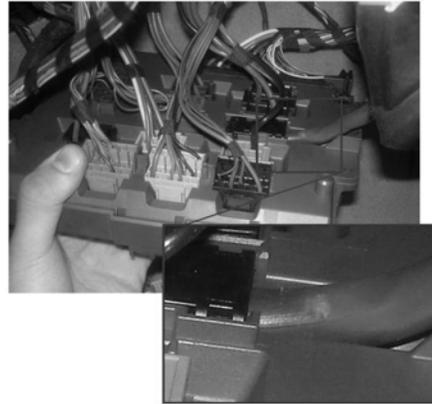
- Poor B+ connection at front fuse box

- If any discoloring is found on cable insulation replace the cable and the front fuse box
 - New B+ cable part numbers with silver coating at connection point
 - E82/E88 – 61 12 9 269 909
 - E9x – 61 12 9 269 907
 - E89 – 61 12 9 269 914
 - Fuse Box – refer to EPC part unchanged

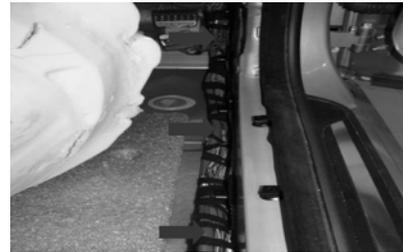
- Cable is routed in wiring harness along RH side of vehicle to battery distribution box

- Remove old cable completely from the harness
- Install new cable in the harness and secure properly

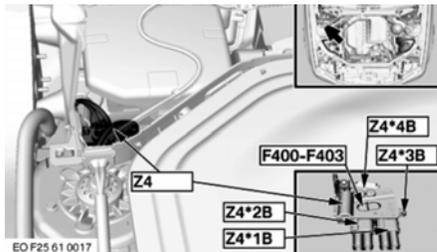
- F25 (X3)
 - Vehicle will not start
 - Various warning lights and check control messages in instrument cluster

- Loose cable connection (retaining nut loose) at junction point (Z4)

- Inspect all components for any damage and replace as needed
- Torque cable nut to proper specs (refer to ISTA)
- Thanks for submitting Cases;
 - Morgan Granger – Towson BMW
 - Aaron Happ – BMW of Rochester

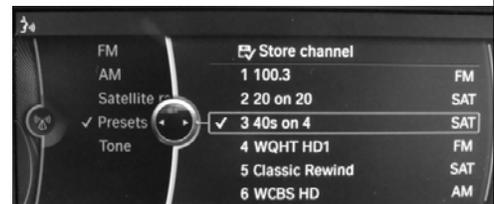
- E60/E61 (5 Series), E63/E64 (6 Series), E70 (X5), E71 (X6), E82/E88 (1 Series), E9x (3 Series) with CIC (SA 609, Satellite Radio (SA 655) and Voice Input (SA 620)
 - When a satellite radio channel is stored on Preset #2 it cannot be selected via a voice recognition command (iSpeech)
- Note: AM/FM channels are not affected

- Under investigation

- Do not replace parts and do not perform a repair attempt!
- Explain the situation to the customer
- For now no satellite radio channel should be stored on Preset #2
- SI B65 10 11 to follow

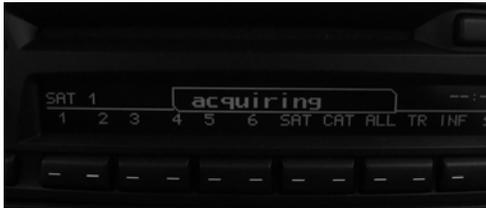
- All vehicles with Satellite Radio (SA 655)
 - Satellite radio has brief reception loss or distortion, ACQUIRING is displayed
 - In a dense urban area (high buildings)
 - Under trees with foliage
 - Under bridges
 - In tunnels
 - In certain mountain valleys

- Vehicle loses site of the satellite

- Do not replace parts and do not perform a repair attempt!
- Explain the situation to the customer
- Refer to SI B65 02 05

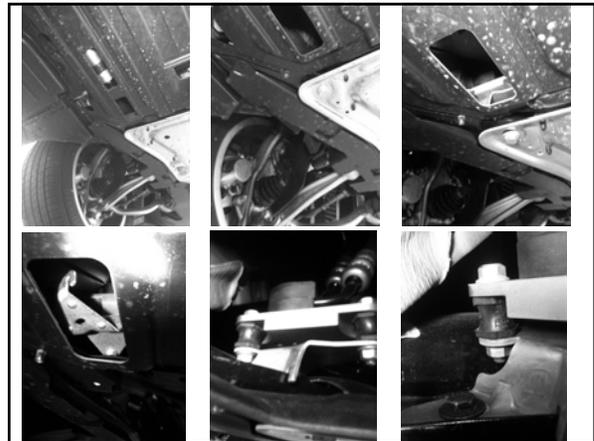
Rattle being heard on acceleration from front of the car from about 30-45 mph

power steering hose bracket not bolted to the left rear area of the subframe

Found power steering hose bracket at the rear of the subframe not bolted down. Installed a bolt and installed the bracket into the proper location. As requested, I've attached more pictures of the car. They are the images named 6.8.11a-e. I tried to get better images starting from farther away and moving in closer. The location of the bracket could not be determined well enough, so I was informed. The bracket that was loose is at the drivers rear corner of the subframe, right next to the drivers side rear corner of the reinforcement plate. Take note there is a nut insert right next to the plate as well, which is what the bolt threads into. I do not have picture editing software that allows me to apply circles to the area, or I would do that. The last image shows the view from above where I installed the bolt, which is black in color. Let me know if these images are sufficient.

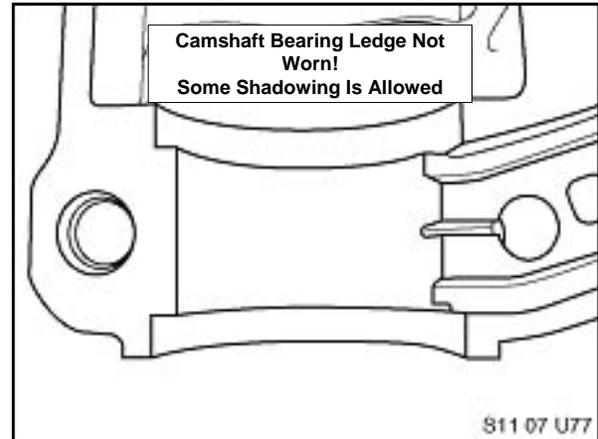
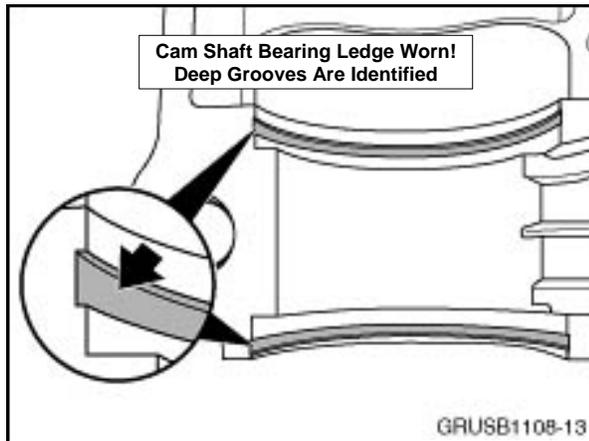
- Step 5 of the VANOS test plan
 - Indicates need to inspect the camshaft bearing ledges
- Parts are being replaced that are not worn

- If the VANOS test plan is inconclusive:
 - Inspect the oil filter cap insert
 - Replace both VANOS solenoids
 - Replace the engine oil and filter
- SI B11 02 08 has been updated
