This Service Information bulletin supersedes SI 18 02 12 dated May 2012.

Voluntary Emissions Recall Campaign 11E-A03: Check and/or Replace Emissions Monitoring Components

E70 and E90 with the M57Y engine produced from January 2008 to September 2009

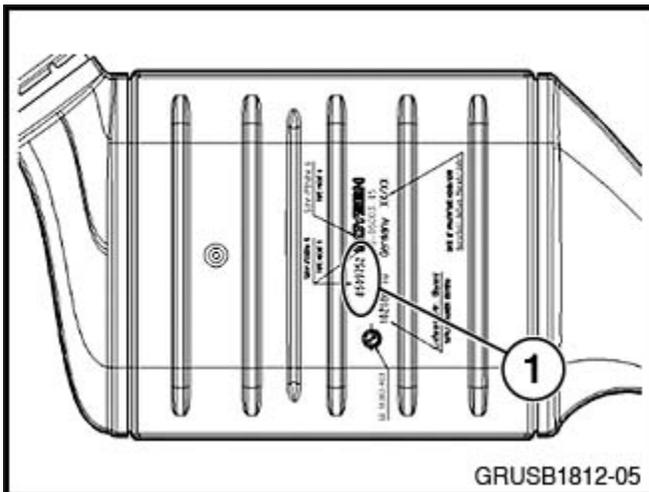
Inspecting the SCR catalyst:

NEW Check the part number of the SCR catalyst (1). If the part number is not 18 30 8 509 752/753 (E70) or 18 30 8 509 749/750 (E90), the SCR catalyst will need to be replaced.

Note: If replacement is necessary, also perform the SCR mixer check/replacement at the same time.

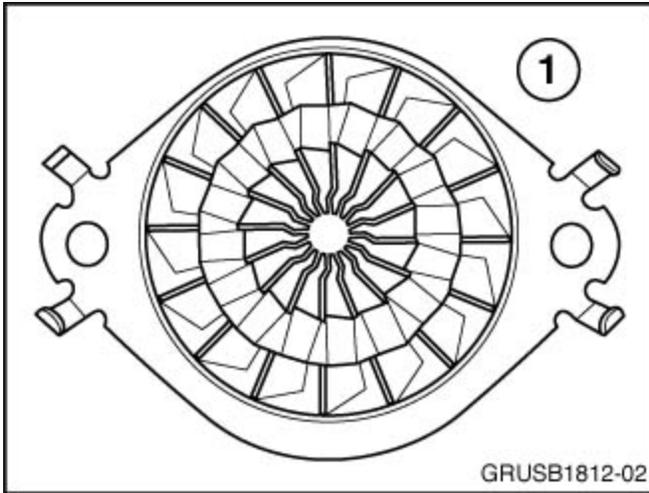
Inspecting the mixer:

The original style mixer has a multiple fin arrangement (1). This mixer will

need to be replaced with P/N 18 30 8 513 445 (E70) or P/N 18 30 8 512 438 (E90).

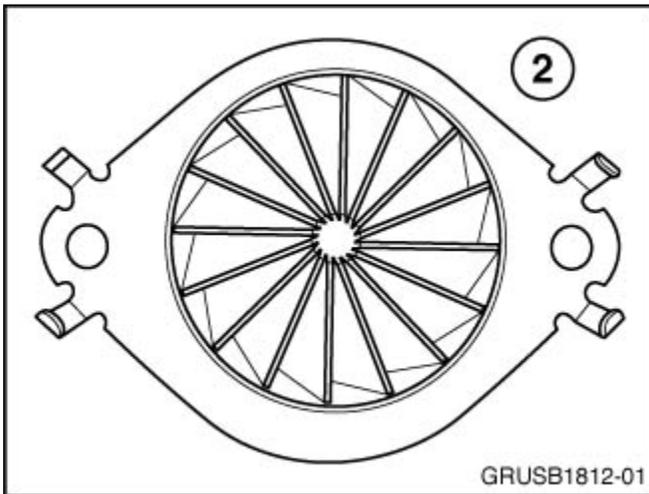
If the updated mixer has already been installed, it will have one set of fins (2). No replacement is necessary. Reinstall the SCR front pipe to the down pipe of the DPF.

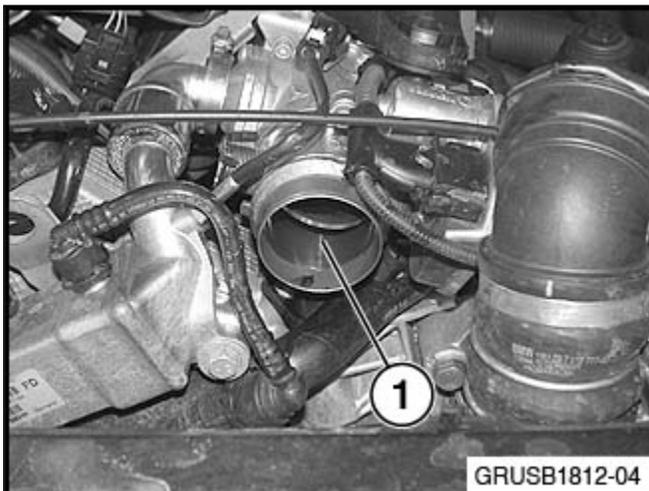
Inspecting the EGR valve:

Remove the charge air pipe at the throttle (ignition off). Using a flashlight, look through the throttle (1) and inspect the EGR valve.

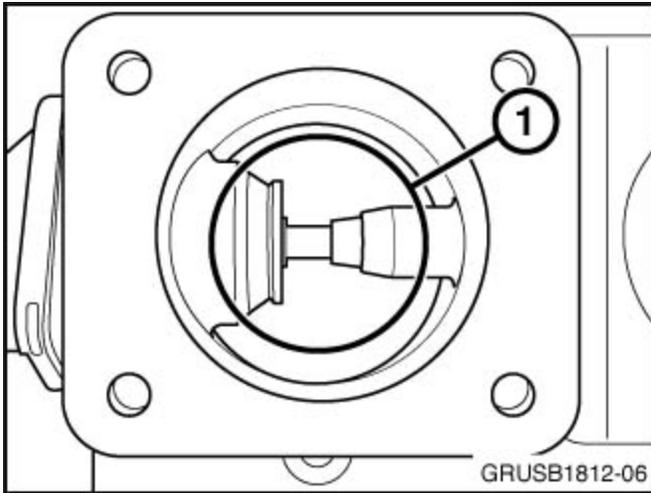
The updated EGR valve (P/N 11 71 8 517 217 or P/N 11 71 8 512 526) has the valve and seat directly in the airstream of the throttle (1). If this valve is installed, no further action is needed. Reinstall the charge air pipe.

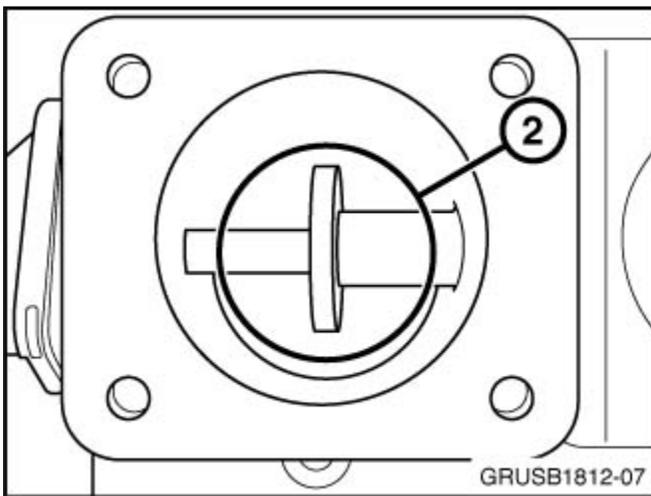
The original EGR valve has a diffuser in the airstream flow from the throttle (2). The valve for EGR actuation is seated further into the EGR airstream. Replace this valve with P/N 11 71 8 512 526 (Repair Instruction 11 71 501).

The DDE will also need to be programmed as part of the Recall. If the EGR valve is replaced, the DDE will need to be programmed after the new EGR valve is installed. This new software package contains the necessary software to adapt to the new EGR valve strategy.
