**Voluntary Emissions Recall Campaign 11E-A03: Check and/or Replace Emissions Monitoring Components**

**NEW** E70 and E90 with the M57Y engine produced from April 2009 to September 2010

**NEW** This Emissions Recall Campaign involves X5d (E70) and 335d (E90) models that were produced from April 2009 to March 2011.

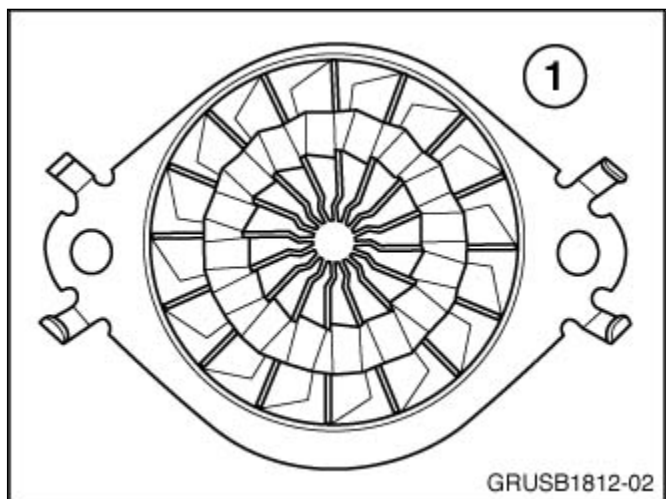
The original style mixer has a multiple fin arrangement (1). This mixer will need to be replaced with P/N 18 30 8 513 445 (E70) or P/N 18 30 8 512 438 (E90).

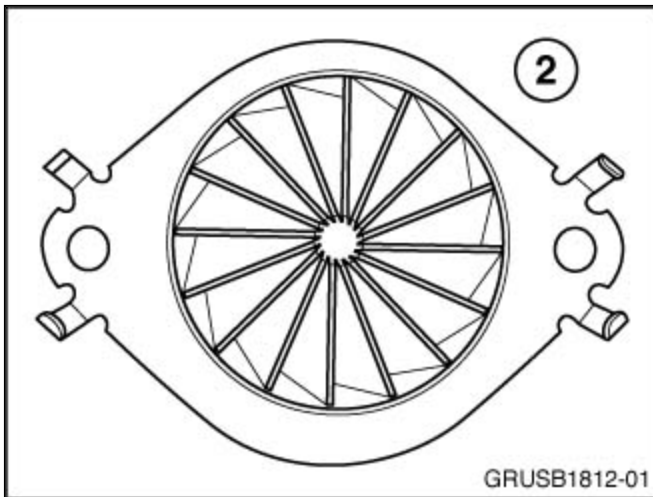
If the updated mixer has already been installed, it will have one set of fins (2). No replacement is necessary. Reinstall

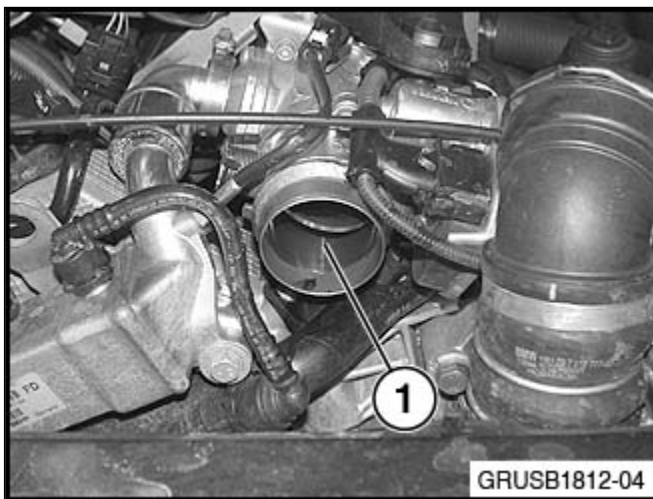
Remove the charge air pipe at the throttle housing (ignition off). Using a flashlight, look through the throttle (1) and inspect the EGR valve.

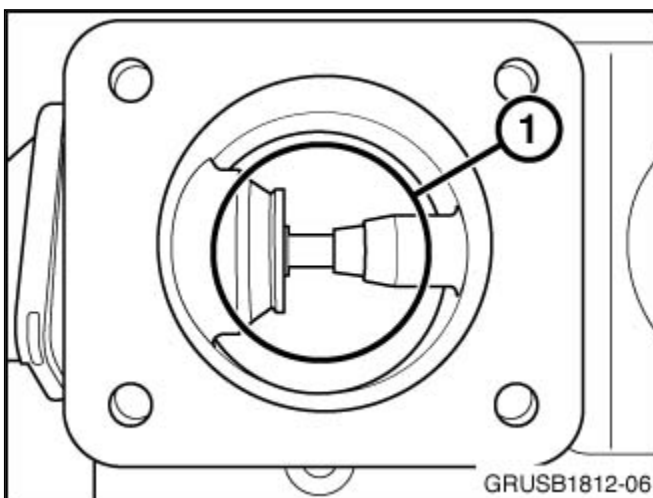
The updated EGR valve (P/N 11 71 8 517 217 or P/N 11 71 8 512 526) has the valve and seat directly in the airstream of the throttle (1). If this valve is installed, no further action is needed. Reinstall the charge air pipe.

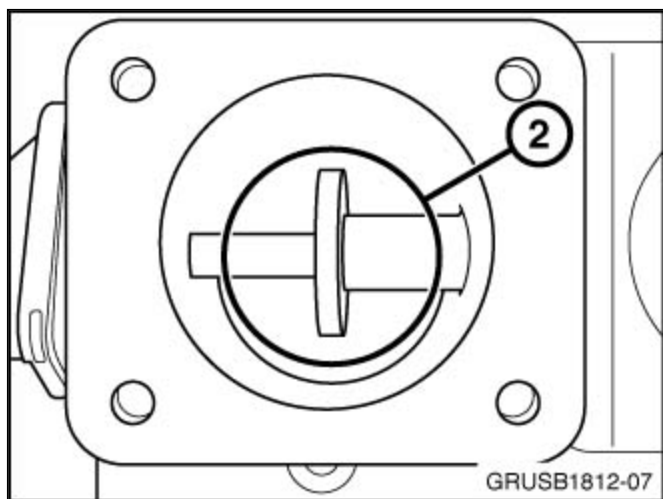
The original EGR valve has a diffuser in the airstream flow from the throttle (2). The valve for EGR actuation is seated further into the EGR airstream. Replace this valve with P/N 11 71 8 512 526 (Repair Instruction 11 71 501).

The DDE will also need to be programmed as part of the Recall. If the EGR valve is replaced, the DDE will need to be programmed after the new EGR valve is installed. This new software package contains the necessary software to adapt to the new EGR valve strategy.
