This Service Information bulletin supersedes S.I. B51 02 05 **dated December 2006**.

### Squeaking Noise From Door Frame Area While Driving

E60, E61 (5 Series)

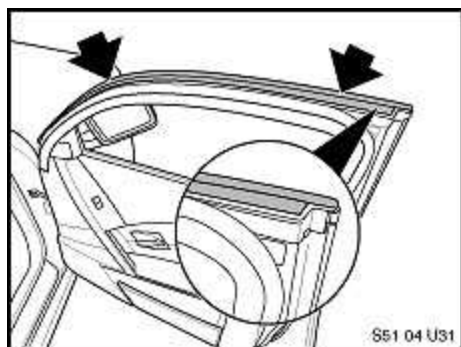
Movement between the flocking material (felt-like material indicated by the arrows) on the upper door seal and the surrounding roof panel may produce squeaking or creaking noises. These noises may be amplified by contamination or cleaner residue on the door opening.

**In case of a customer complaint**, refer to the procedure outlined below to replace the seals with improved parts and/or apply the specified transparent Teflon tape.
