PROCEDURE

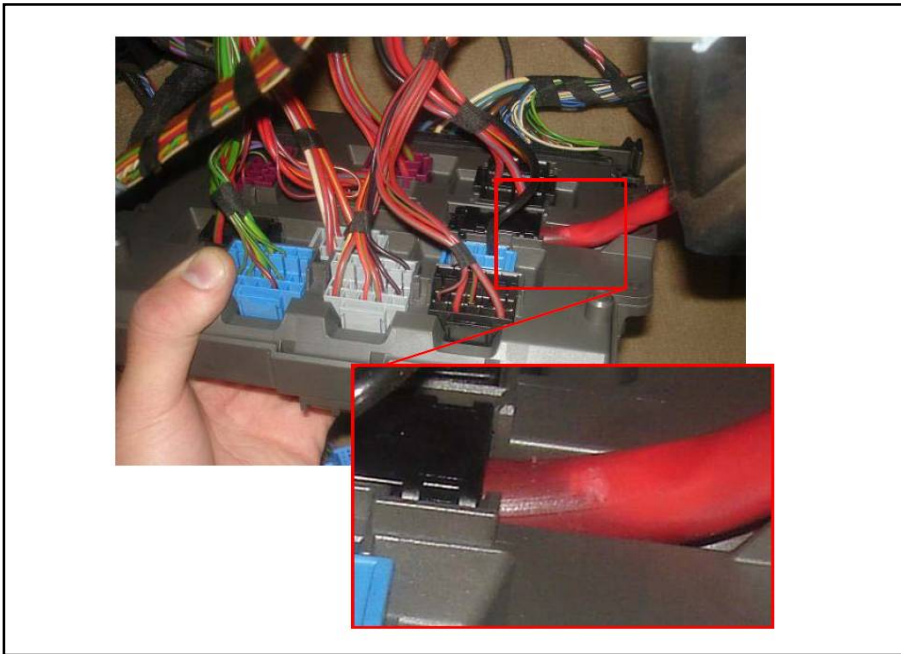
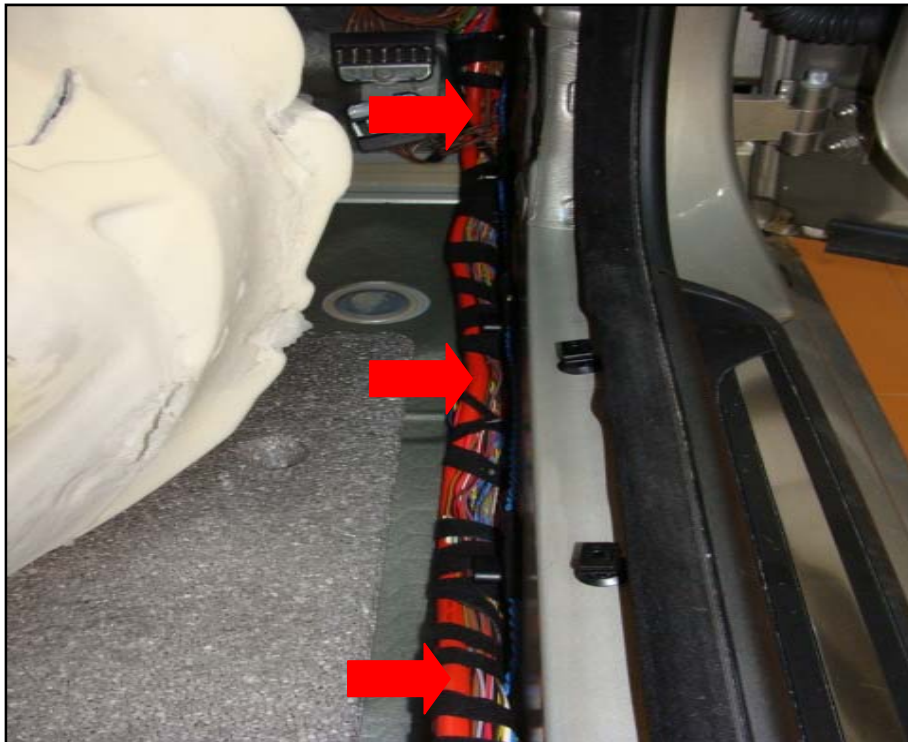
1. Replace the cable and fuse box if any discoloration is evident, as shown in the picture below.

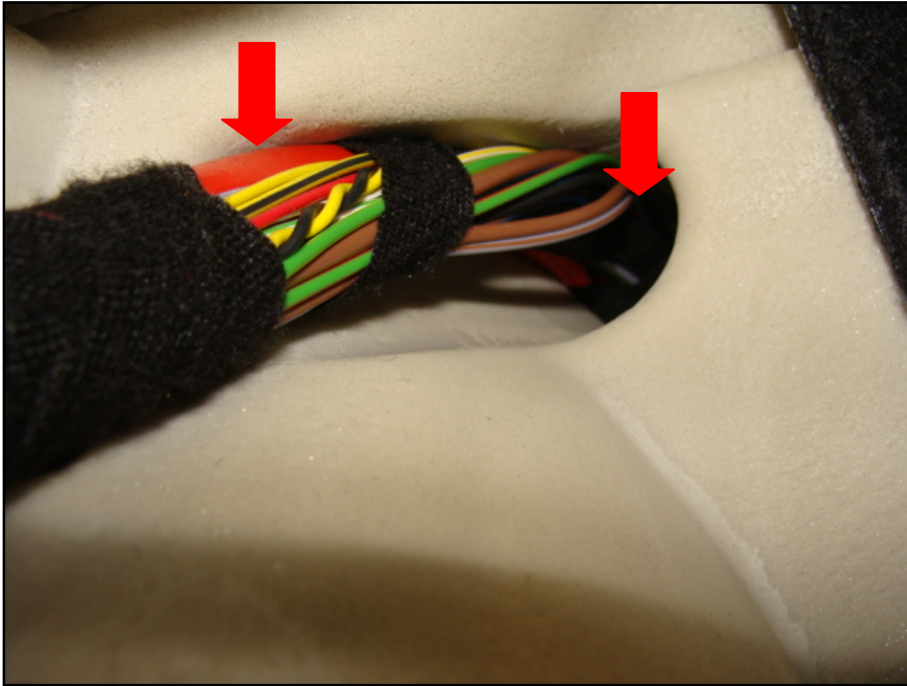
2. Please remove the old cable from the harness.
3. Route the replacement cable in the same position as the existing one. The front passenger door opening area is shown with the passenger seat removed and the carpet moved aside.
Note: The carpet does not need to be fully removed.
4. Ensure that the new cable is not touching or near any sharp edges, and secure in the harness as needed.

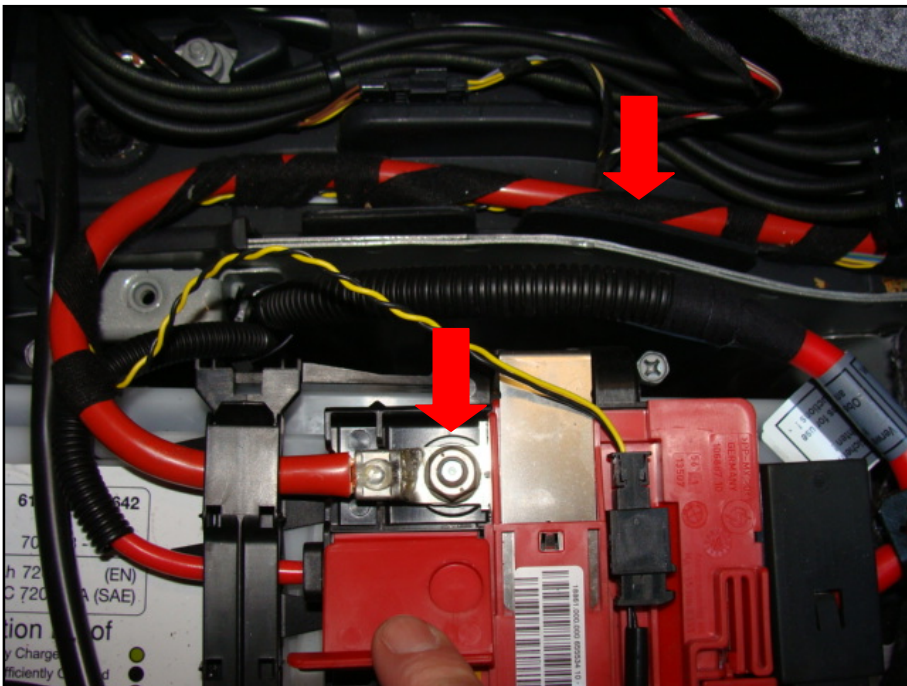
5. The harness routes through the passenger rear seat area into the trunk, as shown in the picture. Ensure that the harness is properly routed through the grommet.

6. Route the harness into the trunk and connect to the Power distribution box mounted on the battery (an E90 vehicle is shown as an example).
7. Torque the battery cable retaining nut to 15 Nm.
