325d Glow plug replacement

Assumptions: This guide is based on a March 2008 UK build RHD 325d with the M57N engine. The guide will be the same for pre LCI 330d models, variations expected for other models. Later cars use different glow plugs, part numbers should be checked with known good sources. **No responsibility accepted for loss or damage to vehicle or persons through using this guide.**

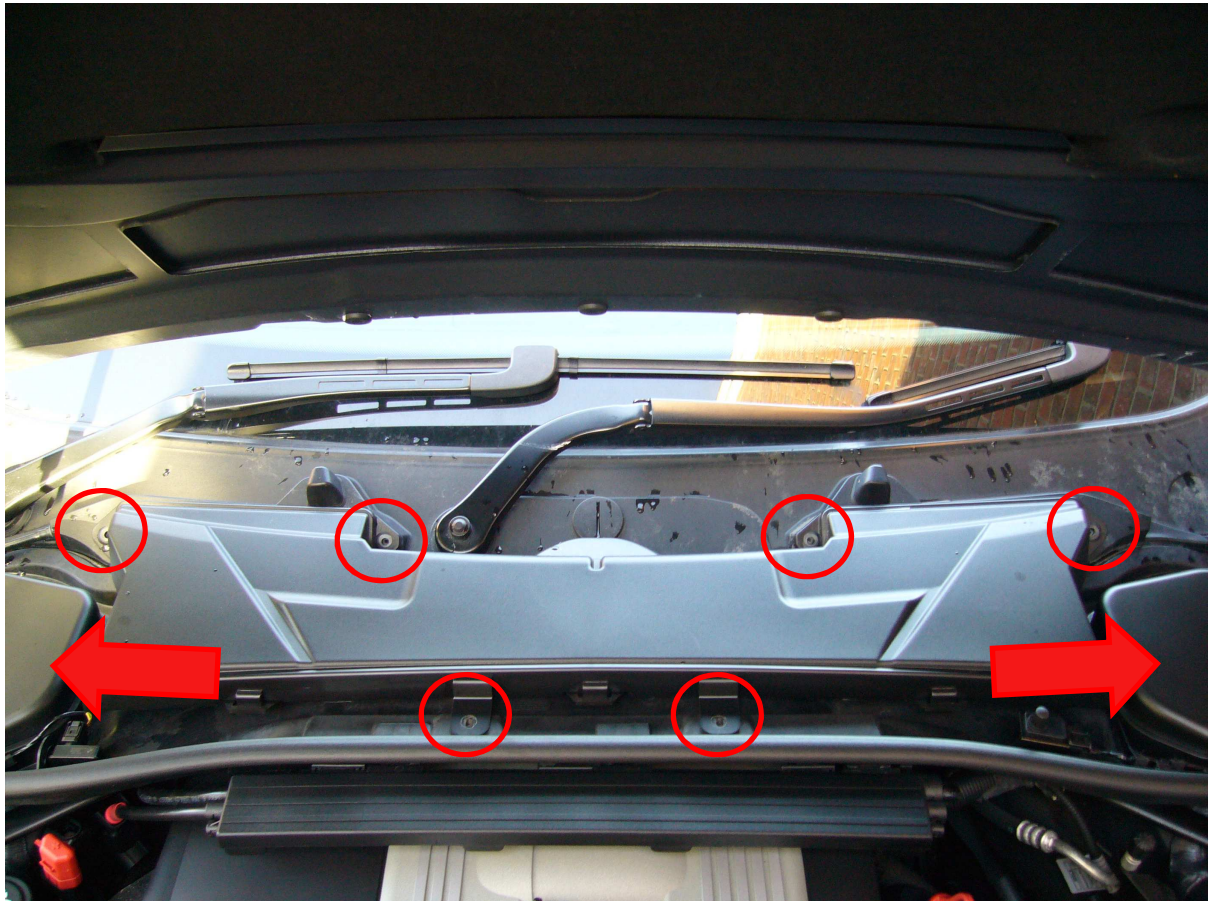
1. Remove brake fluid reservoir cover and ECU cover, undo 6x8mm bolts holding cabin filter and remove.

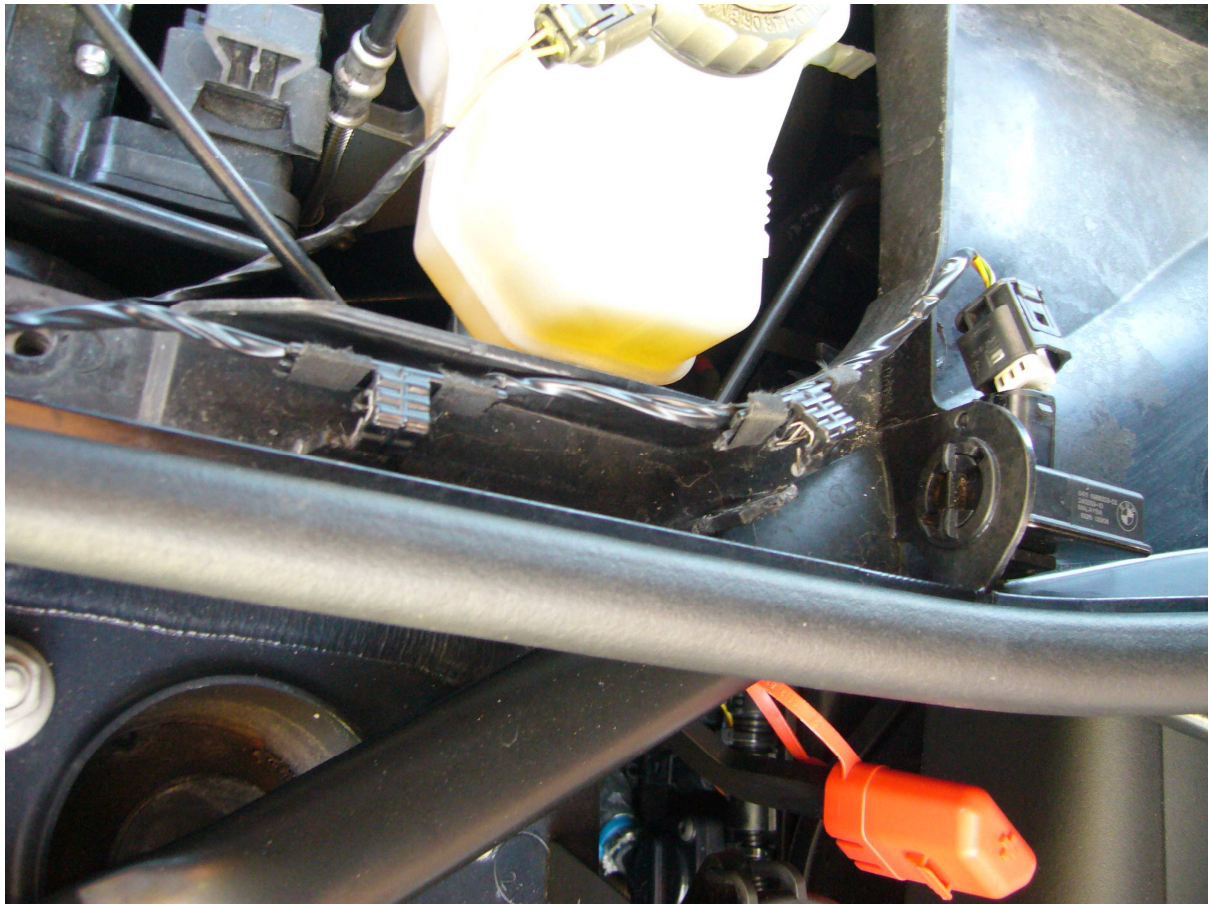
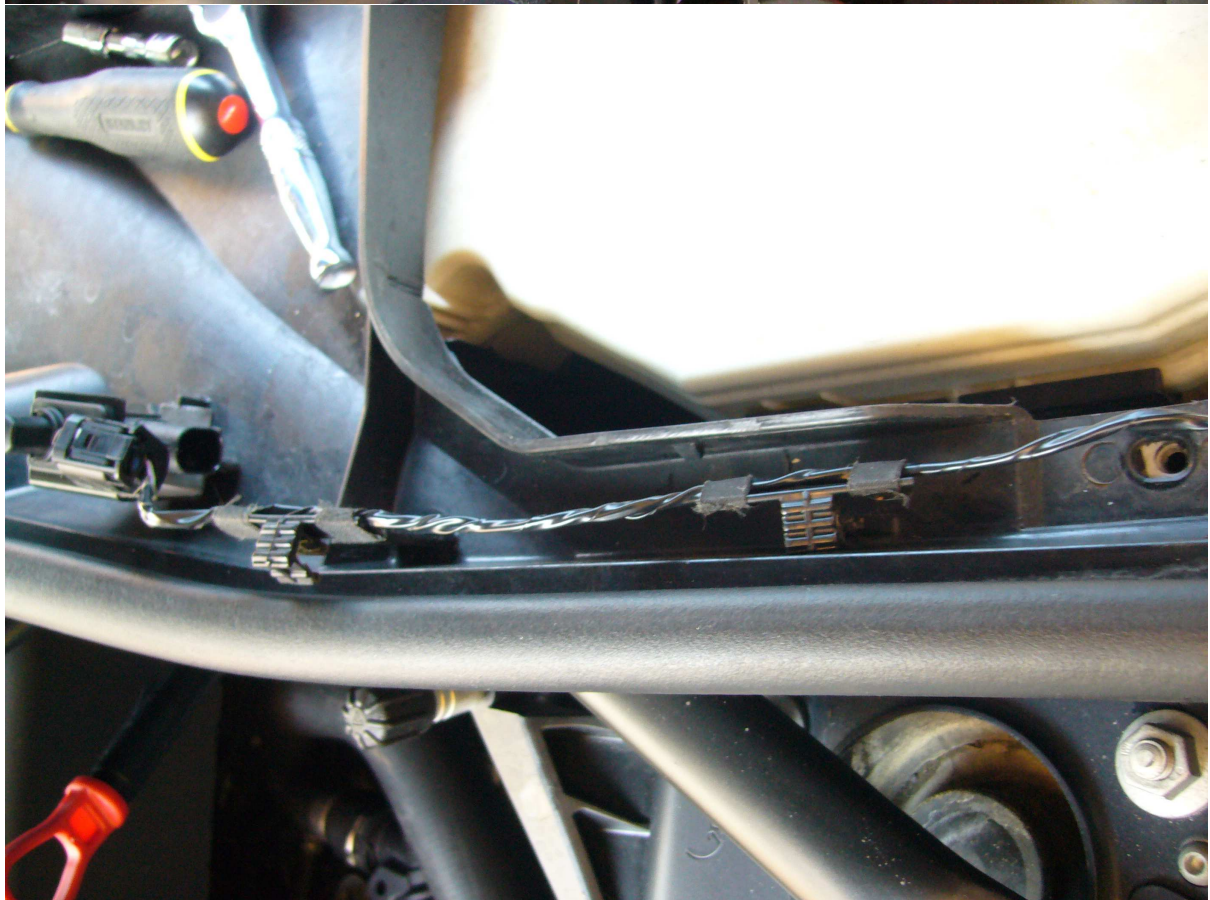
2. Disconnect wiring for bonnet alarm switch on the near side, and the cabin air filter sensor on the off side. The clips can be prised off the posts using a small flat bladed screwdriver.

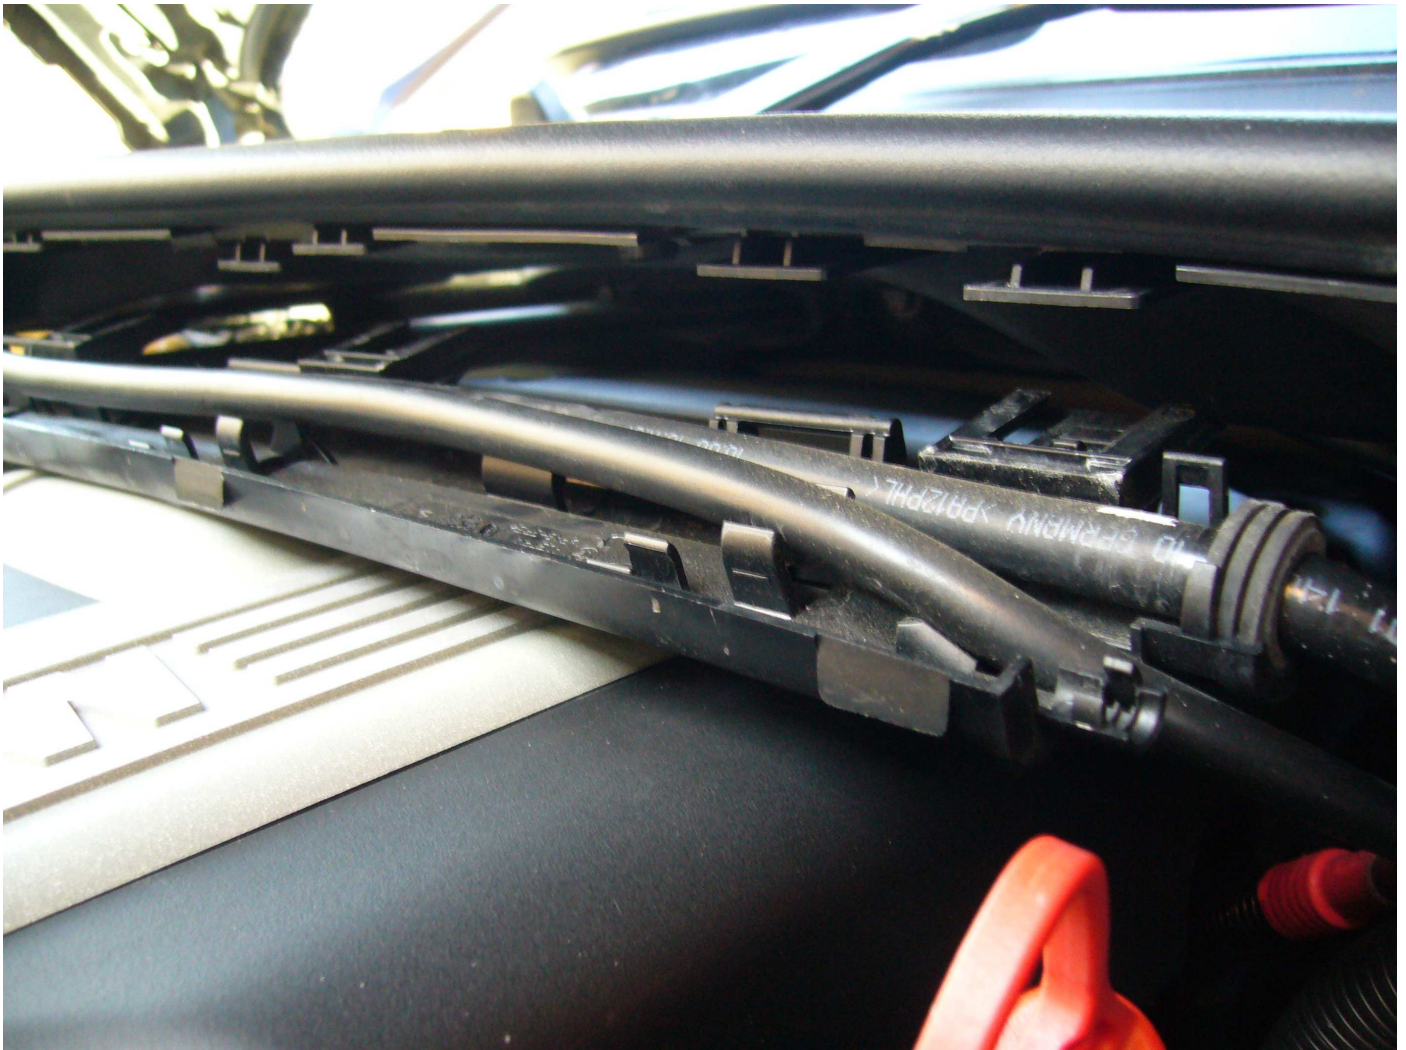
3. Unclip by pulling gently, the three clips holding the battery and vacuum pipe carrier, this is easily damaged.

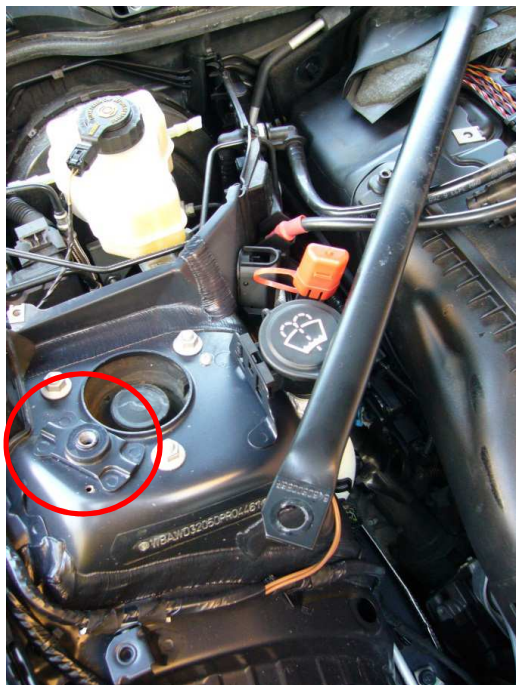
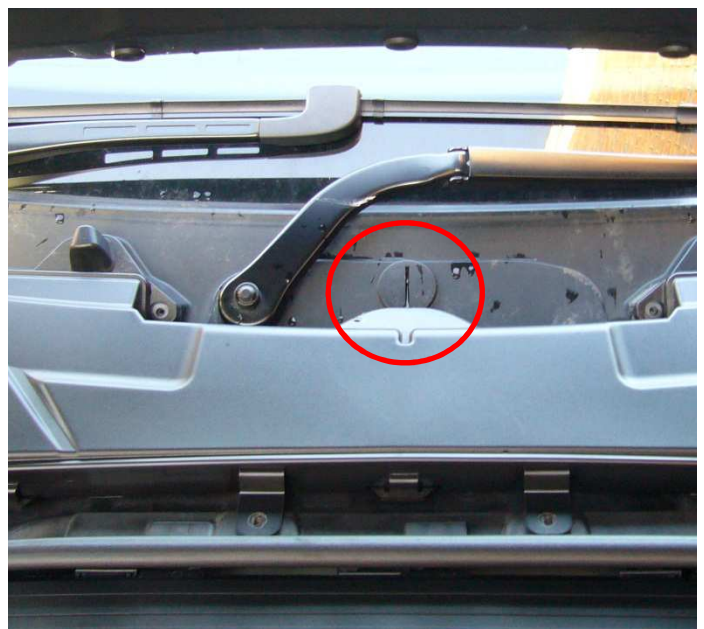
4. Remove the 8mm bolt from either end of the cabin filter cross member support, pull away the rubber bungs holding this panel down to the flaps beneath. The panel is 'tucked' in to the bottom of the windscreen surround, and must be lifted away at an angle.
5. Remove the large bung in the centre of the windscreen wiper trim, this will reveal the torx bolt securing the stabiliser bar, remove this bolt, remove the bolts from the ends of the bar above the suspension struts, and remove the bars.

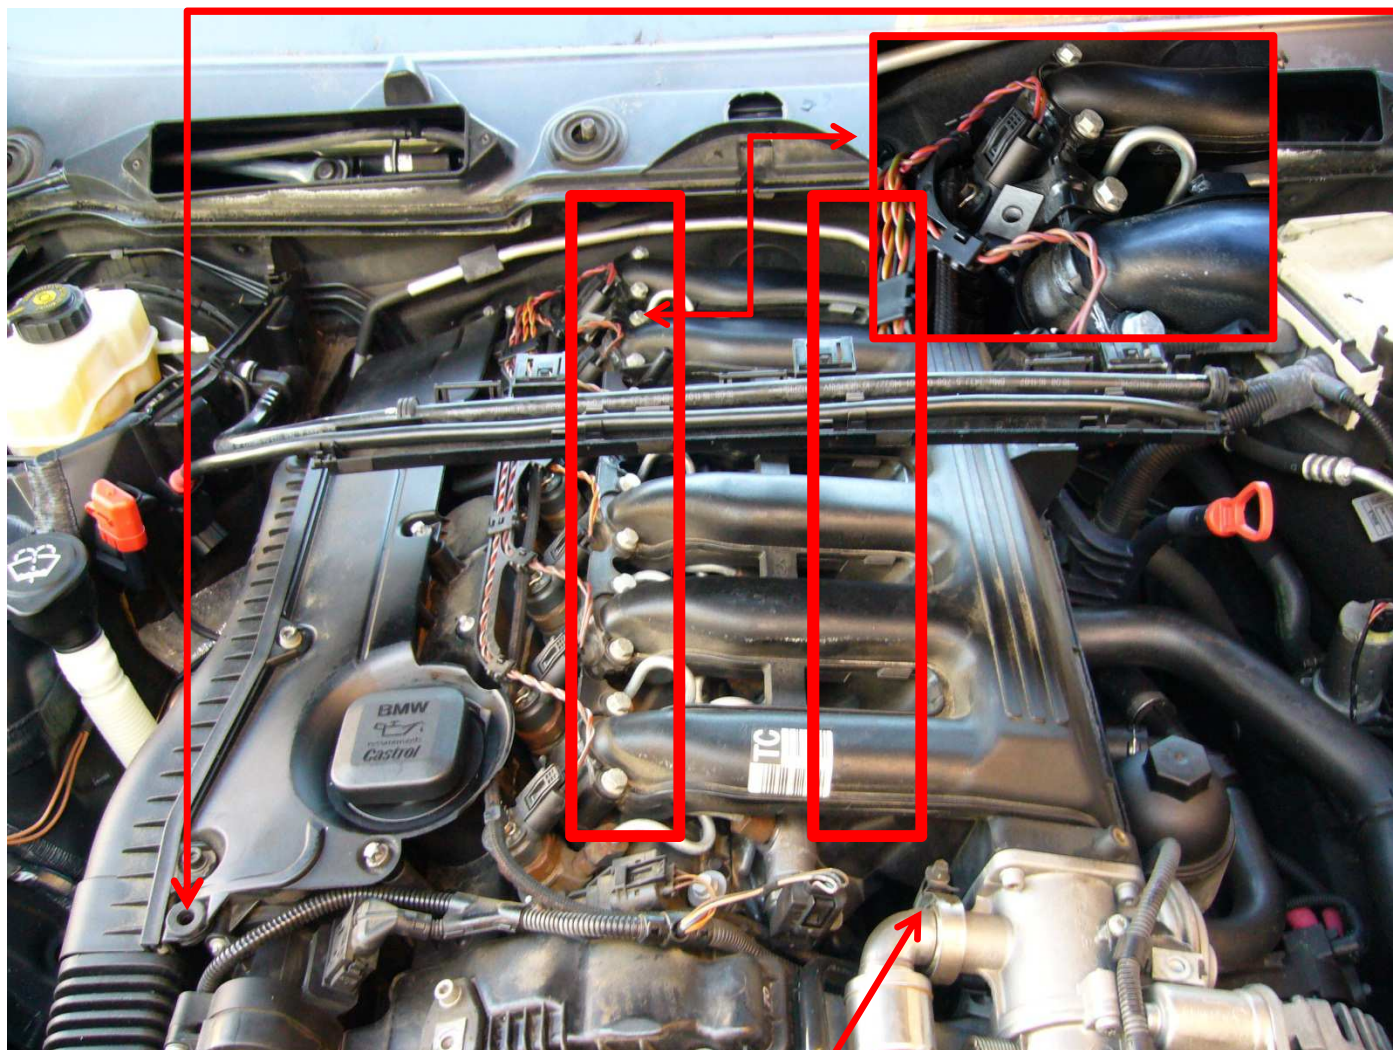
6. Remove the allen bolts holding the engine acoustic cover (4x front, 2x rear) – NB there is a rubber bung securing the left side of the cover, close to the oil filler cap, stressing the cover in this area will result in damage.
7. Remove the bolts holding the intake manifold in place, as marked below, taking note of the engine cover bracket 3 bolts from the back (inset). Some bolts are recessed – these are loose and will need to be carefully removed using thin nosed pliers so as not to drop them.

8. Disconnect EGR valve jubilee clip (seen in bottom right of above photo) Remove the associated plugs and wiring.

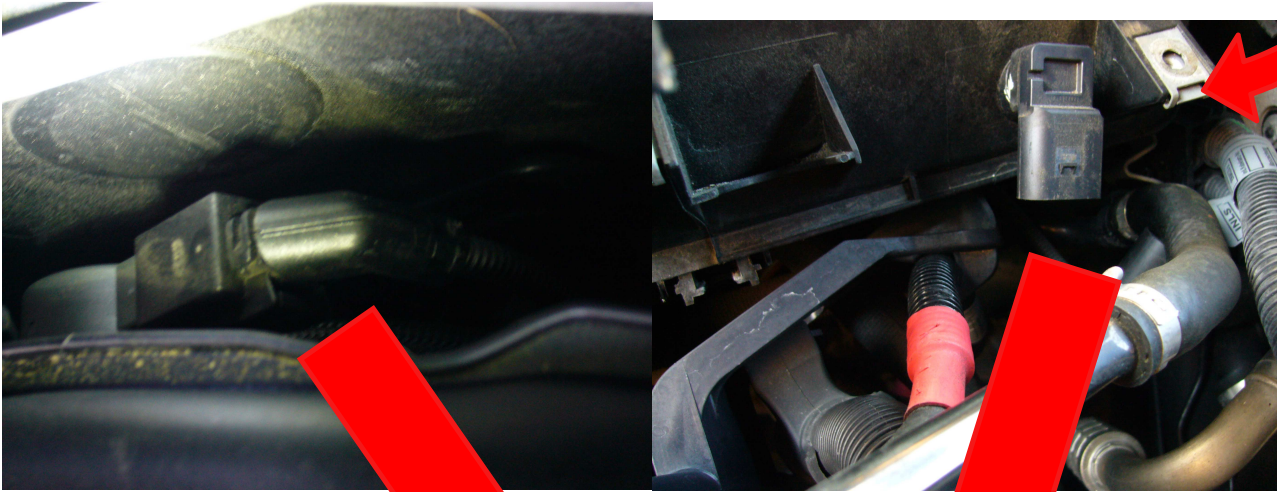
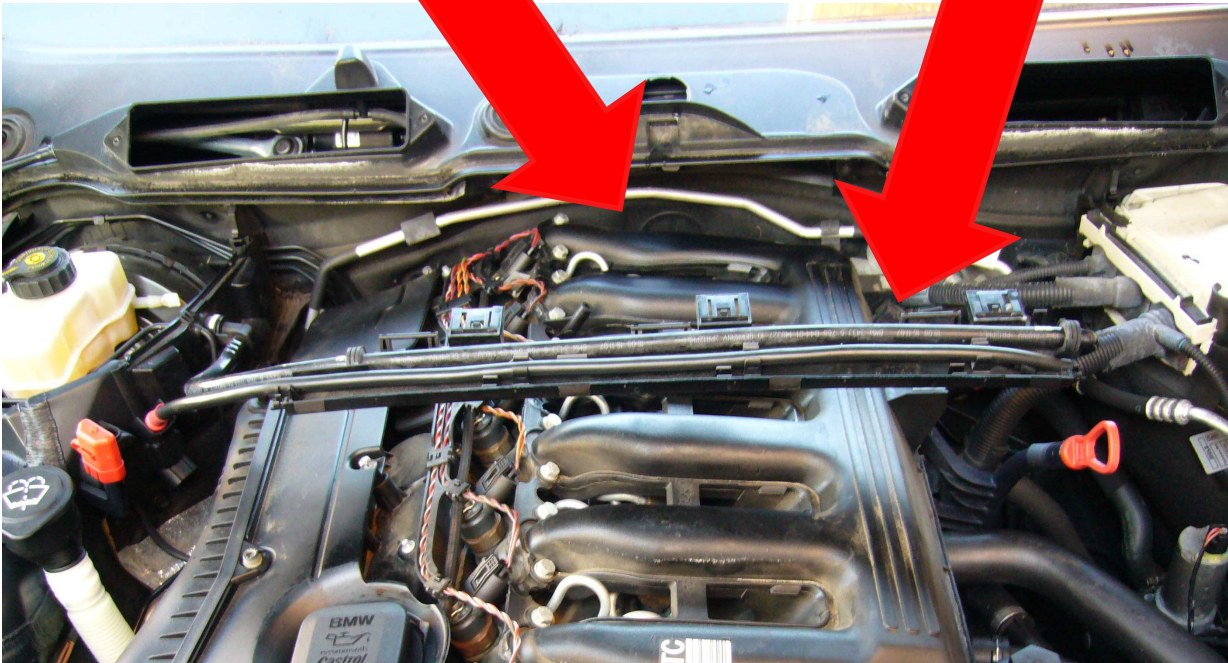
9. Remove wiring connectors, one located on the right of the inlet manifold, and one on the back of the inlet manifold – this fouls the inlet manifold when trying to lift it off. There is also a small bolt holding two brackets to the rear, marked here (not visible) this must be removed.

10. Lift away the inlet manifold – be wary of the vacuum pipe from the EGR valve, personally I could not remove this, in which case the manifold can be rotated and rested on the fan housing (seen here bottom left).

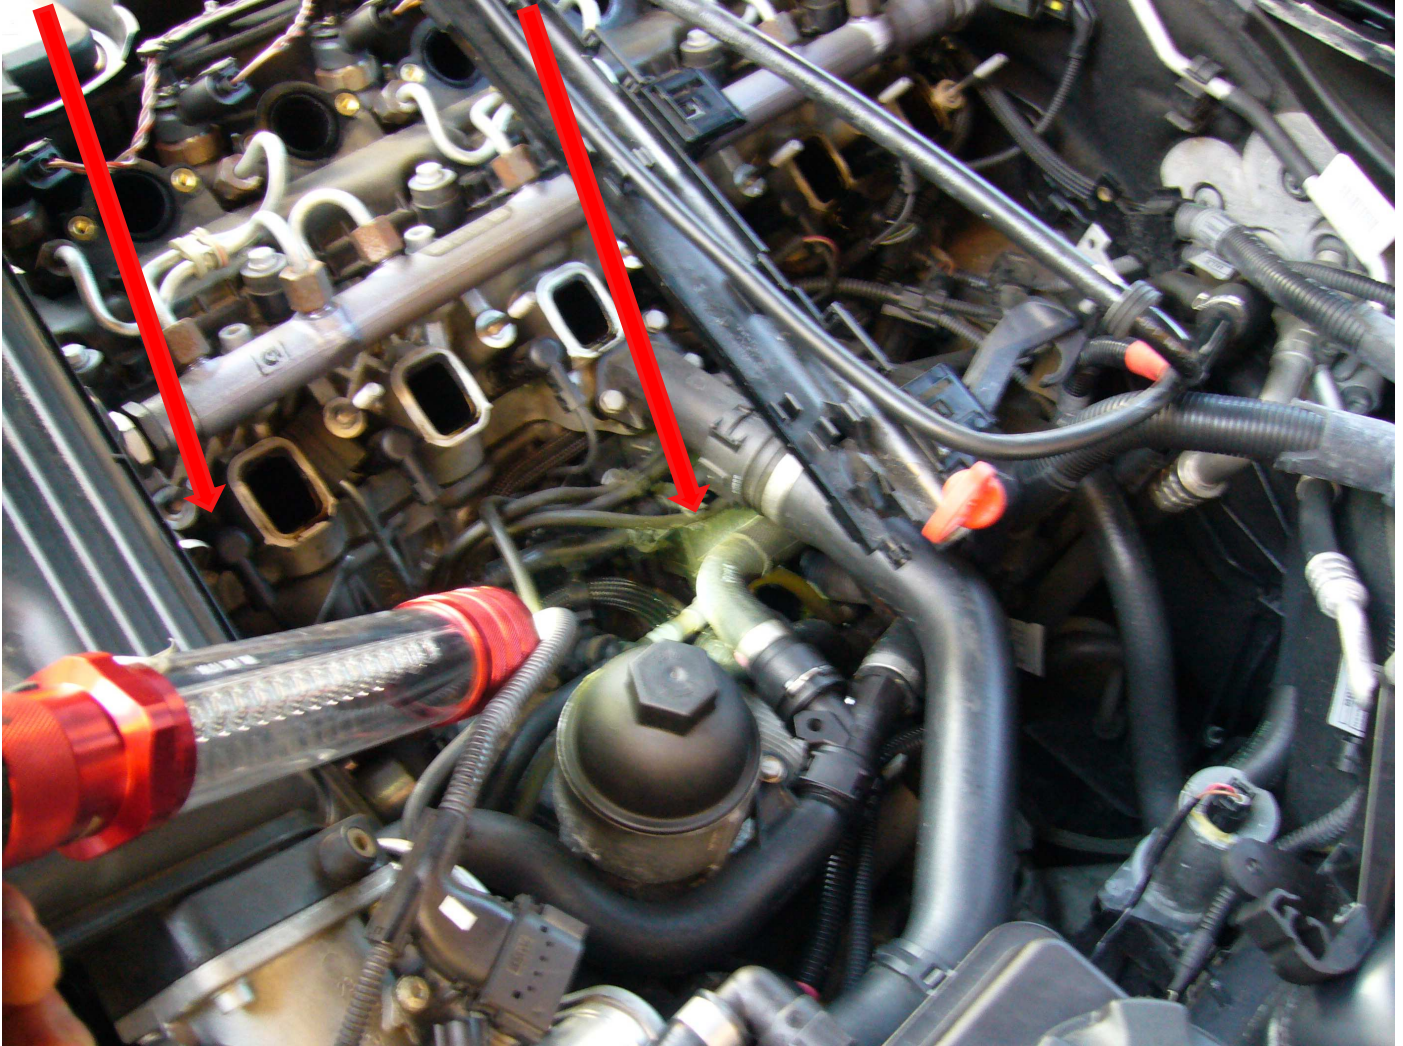
Glow plug controller location (mounted on rear bulkhead on LCI models)

11. Remove the glow plug connectors, these are simple squeeze tabs. Apply plus gas to the base of the glow plugs and leave for 1 hour – this is a good time to start changing the thermostats if you intend to take this opportunity. Also worth noting; location of controller, can be easily changed while you have access.

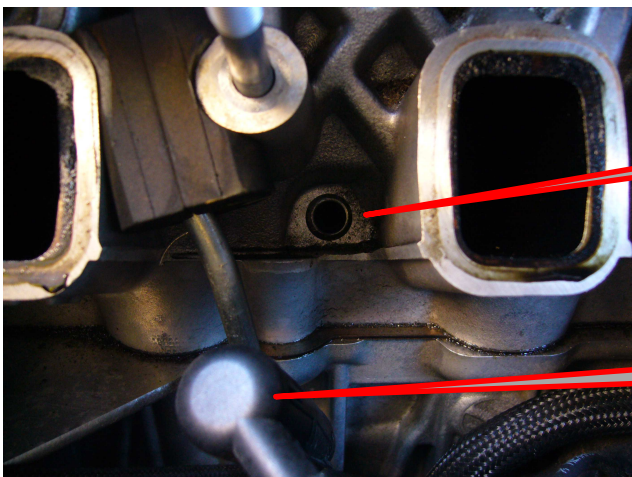
12. Remove the glow plugs using the deep 10mm socket.

Glow plug hole

Glow plug connector

13. Apply copper grease to threads of new glow plugs and torque up.
14. Replace gaskets on inlet manifold and assemble in reverse, ensuring all connectors are seated and bolts torqued up.
