PROCEDURE

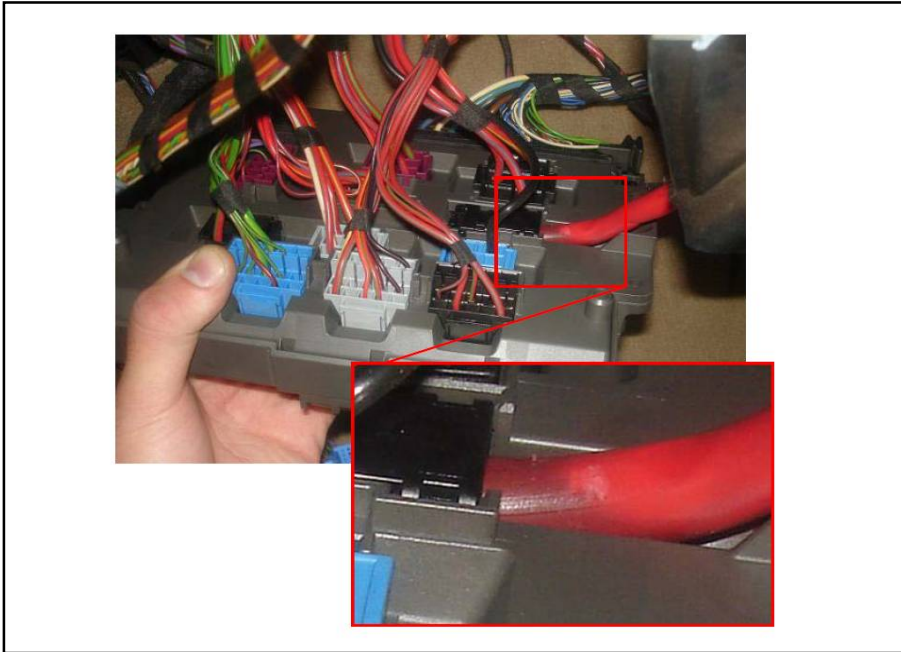
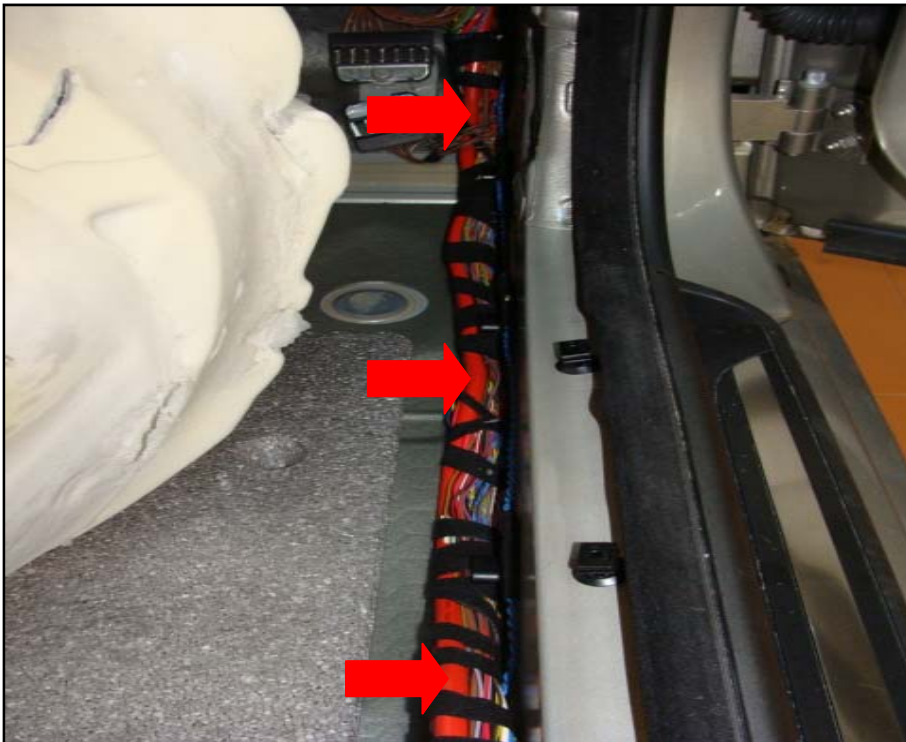
1. Replace the cable and fuse box if any discoloration is evident, as shown in the picture below.
