Fixing the phantom auto misadjusting side mirror position - TSB 513608

BMW TSB SI B51 36 08

Outside Door Mirror Moves When Locking Or Unlocking The Vehicle

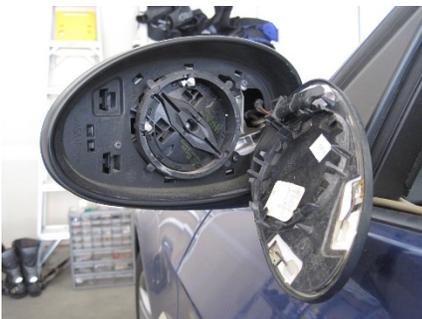
Just did the DIY in about 10 minutes. One thing I haven't seen mentioned yet (probably obvious) is that I **rolled the windows down to make popping the mirror off on the car side a little easier.**

It took me about 10 minutes start to finish. Popped off the mirror with a plastic trim tool, cleaned the pins with a pencil eraser (trick I learned working on radios in the military; those things are all put together with these aluminum pin connectors), blew out the other side with canned air, and put it back together.
