**Service Action: N54 Program Control Units (DME for HDP)**

E60, E61, E71, E82, E88, E90, E92, E93, F01, F02 with the N54 engine produced from 02/06 to 03/10

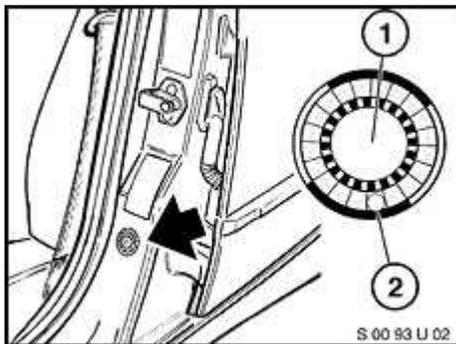
**LABEL INSTRUCTIONS**

This Service Action has been assigned code number **566**. After the vehicle has been checked and/or corrected, obtain a label (SD 92-380) and:

- A. Emboss your BMW center warranty number in the middle of the label (1);
- B. Punch out code number **566** (2), printed on the label; and
- C. Affix the label to the **B**-pillar as shown.

In order to determine whether a specific vehicle has had this Service Action completed or is affected by this Service Action, first check the B-pillar label for code number **566**. If code number **566** has been punched out, the campaign has already been performed. If code number **566** has not been punched out, it will be necessary to utilize the "Service Menu" of DCSnet (Dealer Communication System) or the Key Reader. Based on the response of the system, either proceed with the corrective action or take no further action.
