**Voluntary Emissions Recall Campaign 11E-A03: Replace the SCR Mixer**

E70 and E90 with the M57Y engine

Produced from February 2010 to September 2010

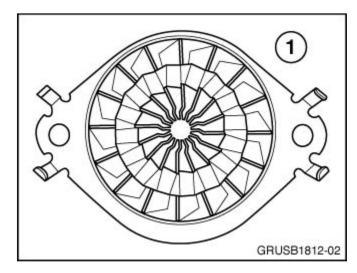
The original style mixer has a multiple fin arrangement (1). This mixer will need to be replaced with P/N 18 30 8 513 445 (E70) or P/N 18 30 8 512 438 (E90).

Replace the mixer (Repair instruction 18 31 140).

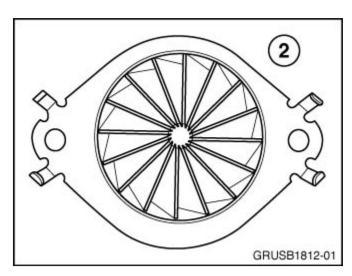
The updated mixer has one set of fins (2).

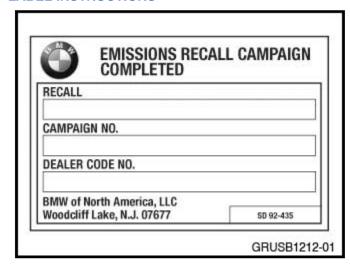
After the vehicle has been checked and corrected, obtain a label (SD 92-435) and with the indelible marker provided, legibly print the Recall name, Recall number, and dealer code (5 digits) on the Recall Completion Label (see illustration).

An initial quantity of **100** labels will be sent to all BMW centers. Peel the label from its backing and affix it to the right (passenger) rear side of the hood in the engine compartment, close to the windshield.

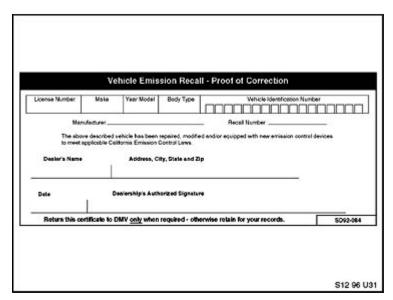
For California centers only: it is required by the California code of regulations that an executed orange "Vehicle Emission Recall - Proof of Correction" certificate (SD92-084, see illustration) be provided to each customer (for vehicles registered in the state of California), once the recall on his or her vehicle has been completed.
