# Installation Instructions

Audio, Alarm

**ALARM KIT - P/N 65 12 0 403 658**

3 Series Sedan (E90):	Select Vehicle Production 03/05 – On*
3 Series Coupe (E92):	Select Vehicle Production 06/06 – On*

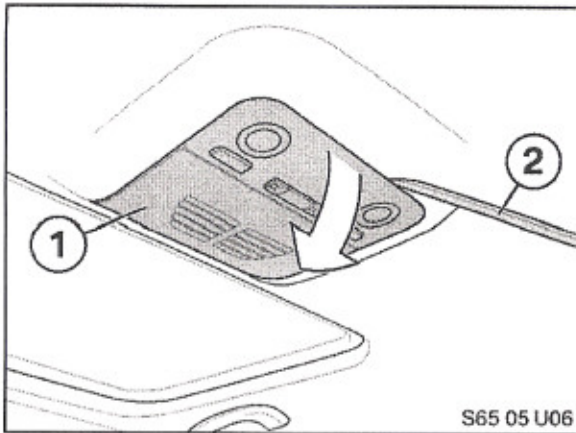
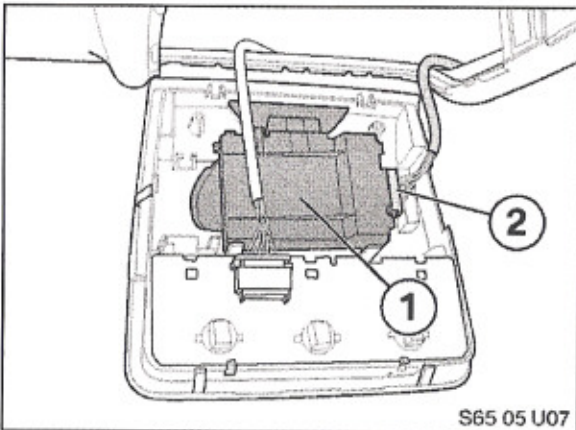
1. Disconnect negative battery terminal.
2. Pry off ceiling light cover (1) from headliner using plastic pry tool (2).
3. Install ultrasonic module (1) into ceiling light as shown.
4. Connect 8-position black connector (2) to ultrasonic module (1).
5. Reinstall ceiling light cover to headliner.

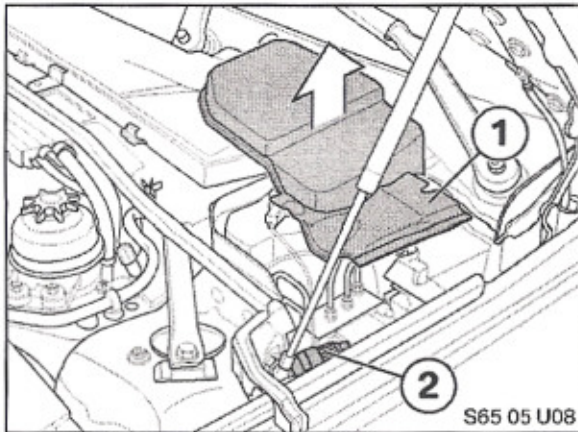
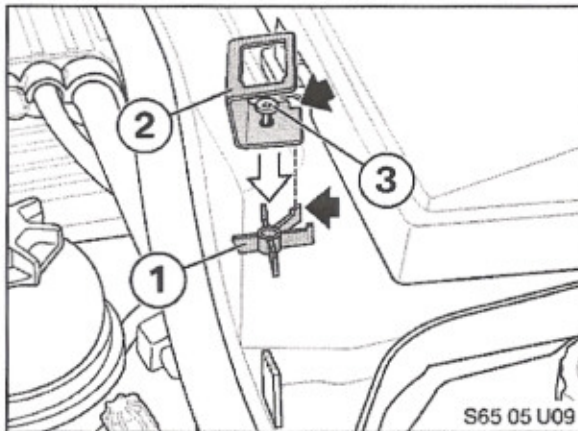
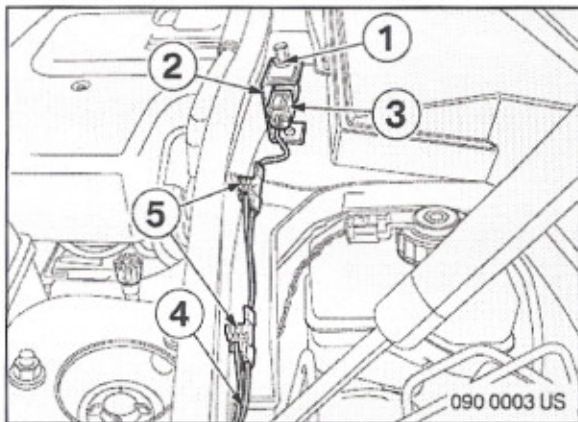
1. Remove cover (1) by LH hood strut area.
2. Locate 3-position black hood switch connector and harness (2). Remove securing tape.
3. Position hood switch bracket (2) to mounting location (1) and secure in place with ST 4.8 x 13 screw (3 ).

*Note: Make sure "corner notch" on bracket faces reward and fits into base mounting tab as shown.*
4. Insert hood switch (1) into hood switch bracket (2).
5. Connect hood switch connector (3) to hood switch (2).
6. Secure hood switch harness (4) by pushing cable clips (5) into mounting tabs.
7. Reinstall cover.

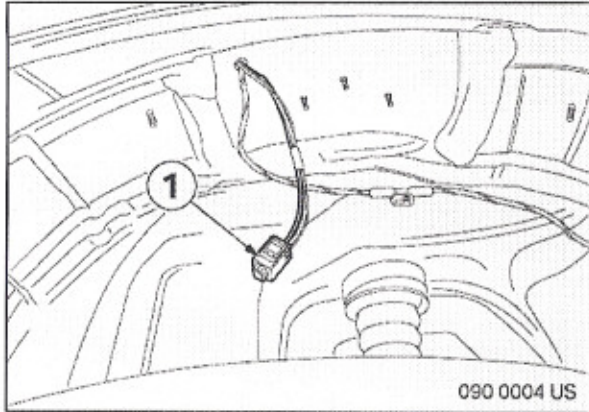
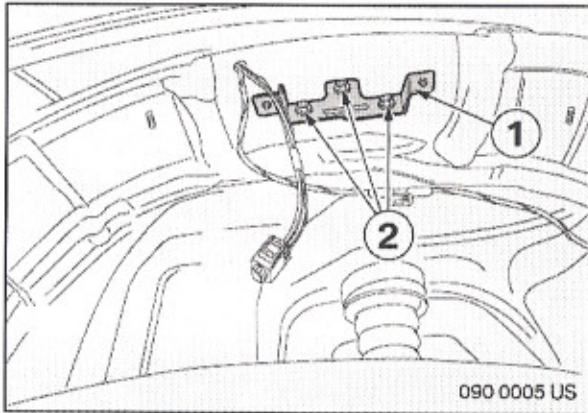
1. Remove LH rear wheel.
2. Remove LH rear wheel arch cover. See TIS 51 71 041
3. Locate 3-position black siren connector (1) in upper LH wheel arch area. Remove securing tape.

4. Install siren bracket (1) over threaded studs and secure in place with M6 hex nuts (2)

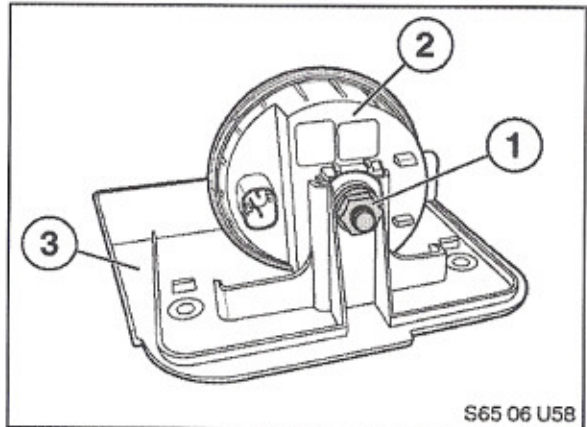
5. Position siren (2) to mounting plate (3) and secure in place with M6 hex nut (1).

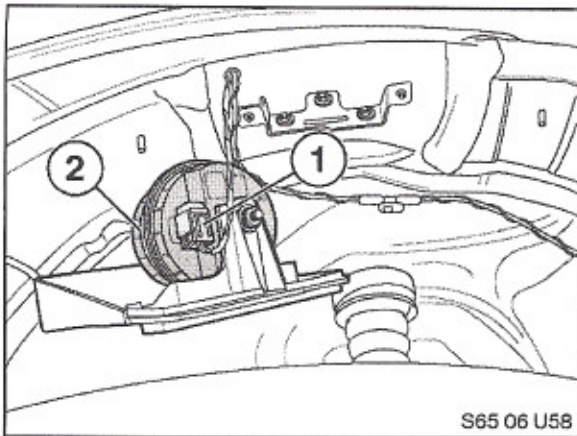
6

6. Connect 3-position black connector (1) to siren (2).
7. Push harness retainer into access hole on siren bracket to keep harness properly positioned.

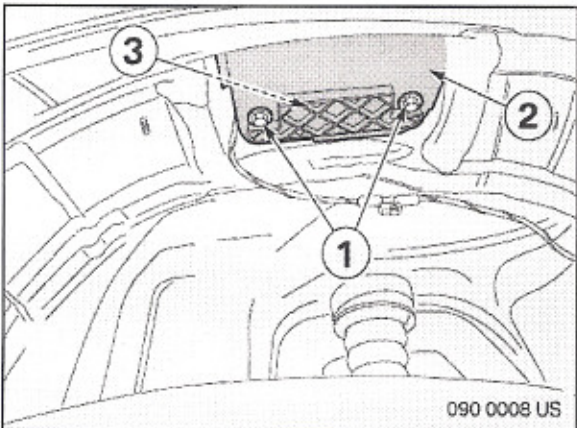
8. Use M6x18 hex screws (1) to secure mounting plate (2) to bracket (3).
9. Reinstall LH rear wheel arch cover.
10. Reinstall LH wheel.

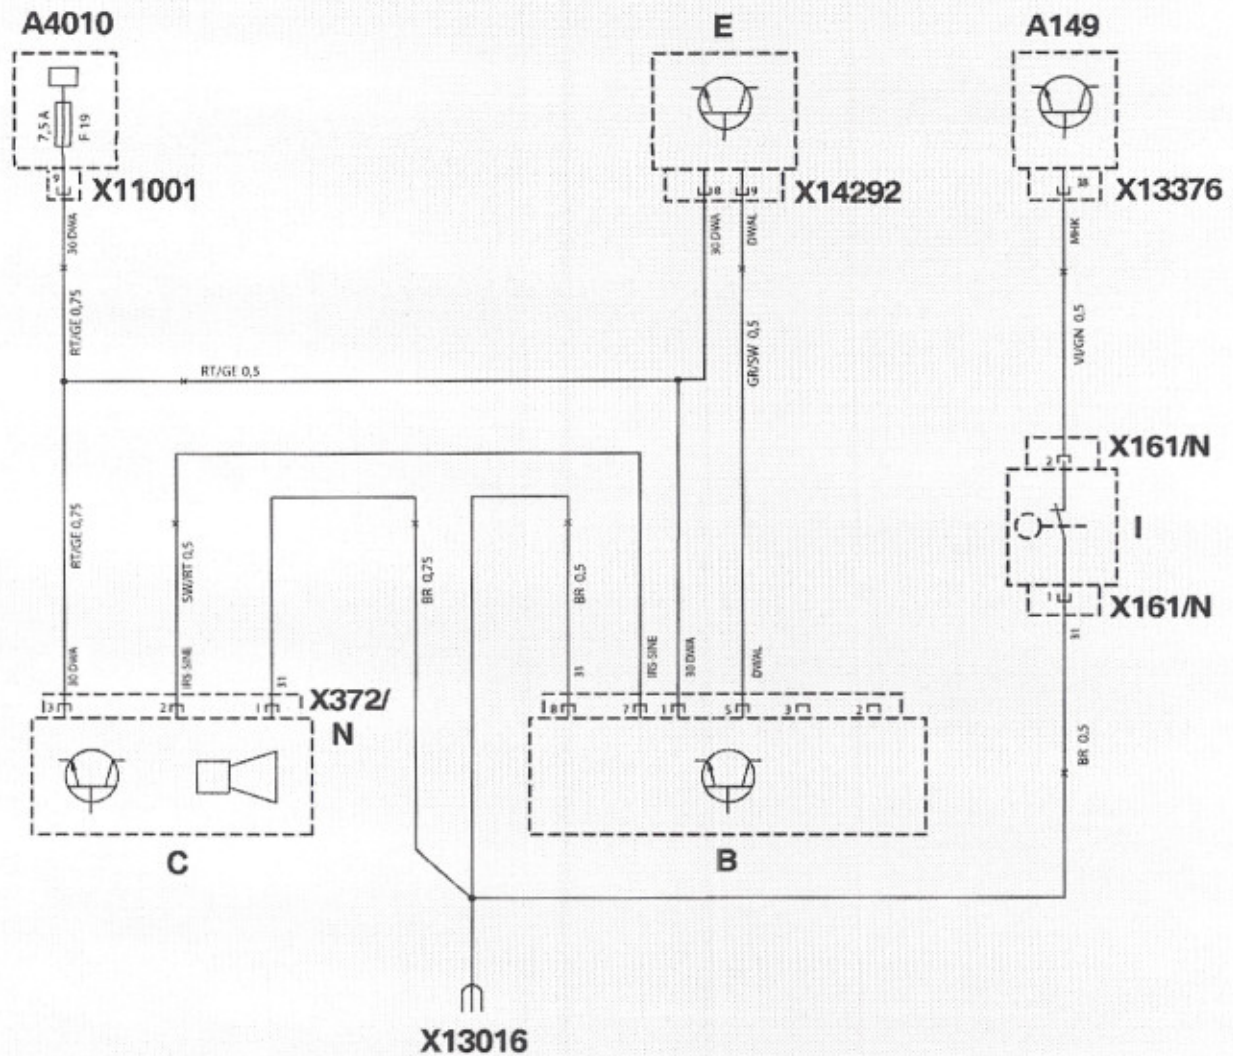
**ALARM SYSTEM CIRCUIT DIAGRAM**

<b>A149</b>	CAS control module
<b>A4010</b>	Fuse holder
<b>E</b>	Interior mirror
<b>B</b>	Ultrasonic module
<b>C</b>	Emergency-current siren
<b>I</b>	Hood switch
<b>N</b>	Black 3-pin
<b>X161</b>	3-pin black plug, to hood switch I
<b>X372</b>	3-pin plug, black to emergency-current siren C
<b>X11001</b>	15-pin black plug, to fuse holder A4010
<b>X13016</b>	Joint connector, terminal 31 tap
<b>X13376</b>	41-pin black plug, to CAS control module A149
<b>X14292</b>	10-pin black plug, to interior rear view mirror
